ZONING MAP AMENDMENT (202300004)

RE: Cornerstone Community Church

Zoning Map Amendment Application

Short Description: Rezoning of R1 to C1 for religious assembly and office use

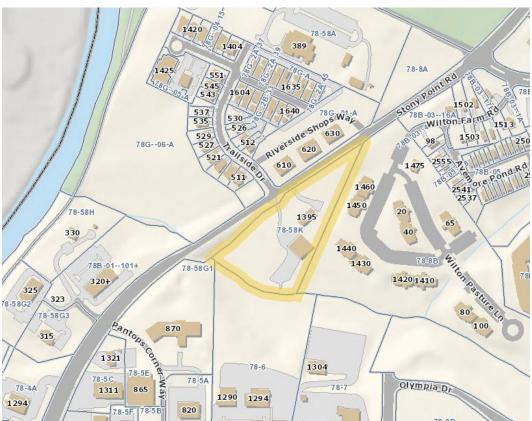
Image 1 - Subject parcel, source: Albemarle County GIS

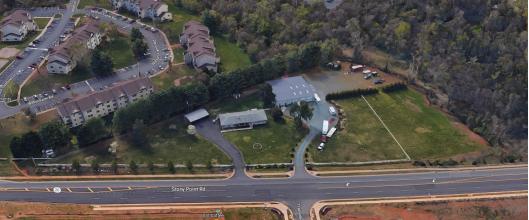
Image 2 - Aerial image showing parcel in context, source: Google

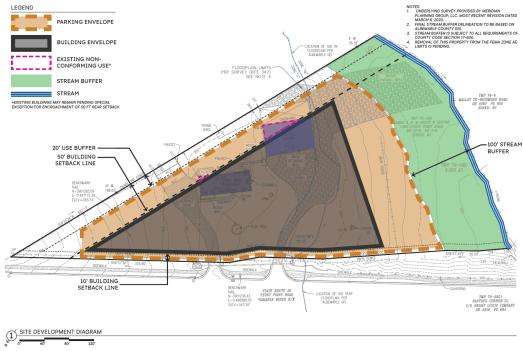
Image 3 – Site Development Diagram

In the first phase, Cornerstone will mostly use the site as-is with minimal improvements required to account for the increased use of the site. The existing carport and frame shed will be removed, along with the rear 27 feet of the garage structure. The remaining portion of the garage will be retrofit for church seating, the residence may be used for an employee dwelling (a parsonage, of sorts) or for youth group meetings, the existing parking lot will removed from within the stream buffer and expanded in areas outside of the stream buffer, public water will be brought to the site, stormwater management improvements will be made, and the northern-most entrance to the site will be closed. This phase will allow for the church to settle into a permanent location and stabilize their congregation after this move.

Phase 2 is a vision for the future of what the site can become. Currently envisioned is an expansion to the church (current garage) structure, an additional office/commercial building up to 3-stories, outdoor recreational areas, and expanded parking. Please see the Site Development Diagram in Image 3 below for proposed general locations of buildings and parking areas. Parking is largely intended to be located to the side of the buildings in accordance with Entrance Corridor guidelines; however, the parking and building envelopes overlap to allow for limited handicap spaces or drive aisles to be included between buildings as necessary. The exact future uses and partnership opportunities for the site are not yet known, which is why the church would like to keep their options open with a C1 zoning designation (see Future Uses in the next section for more information). It is anticipated that these uses will be missional and focused on making a positive impact on the surrounding community.

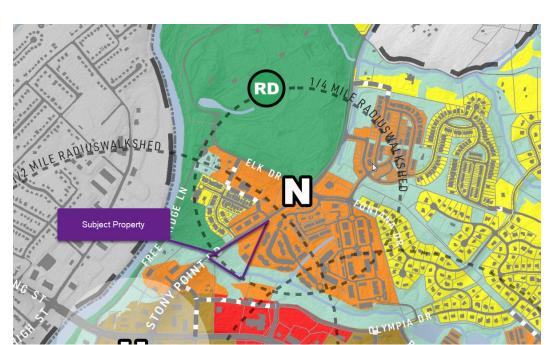
Image 4 - Comprehensive plan designation of subject property, source: Pantops Master Plan 2019

The subject parcel is designated as both Urban Density Residential and Parks & Green Systems within the Pantops Master Plan. Additionally, it is located within a designated Neighborhood Service Center. Refer to Image 4, below.

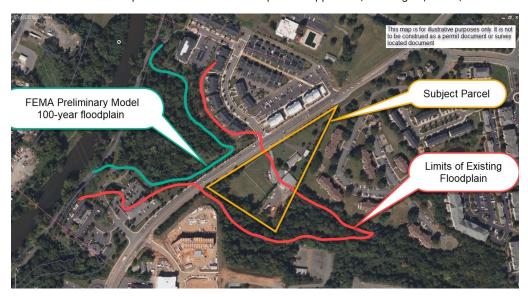
Image 5 - Sketch of existing versus proposed FEMA floodplain limits

Although the current GIS floodplain limits are shown to reach onto this property, FEMA's recently released Draft Flood Hazard Limits shows the revised 100-yr floodplain not encroaching beyond Stony Point Road, rendering this property entirely outside the limits of this overlay once adopted.

existing building and the parking lot are both proposed within this district. However, it is highly likely that the delineation of this district will change in the near future. The district was created to coincide with sensitive environmental features such as stream buffers, floodplains, and steep slopes. Currently the Parks & Green Systems designation coincides entirely with FEMA's 2005 floodplain limits (see Appendix C for 2005 FEMA map), but this designation is not consistent with the current FEMA Draft Flood Hazard Limits which will soon replace the current FEMA maps once approved (see Image 5, below).

In 2022 FEMA shared their Draft Flood Hazard Limits with jurisdictions and industry professionals. This update to the flood mapping removes the subject parcel from the 100 yr floodplain entirely. The revised flood limits are still awaiting a Letter of Final Determination from FEMA, at which point the Board has 60 days to adopt the revised limits. The exact timeline of this process is not known, though it is expected to be complete by 2024.

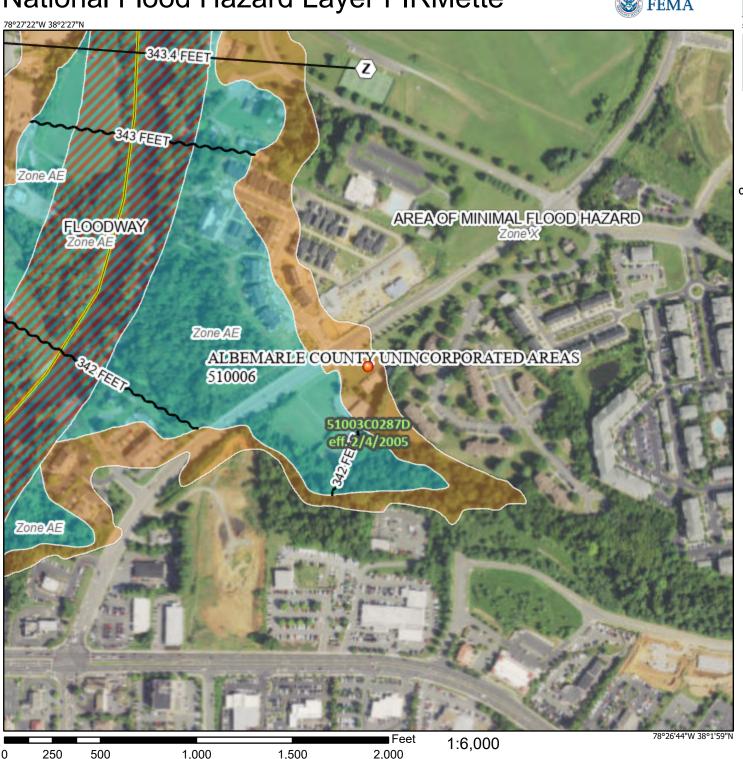
Appendix C 2005 FEMA Floodplain Map

National Flood Hazard Layer FIRMette

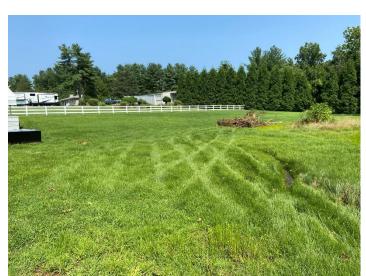
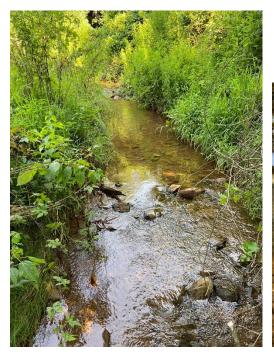
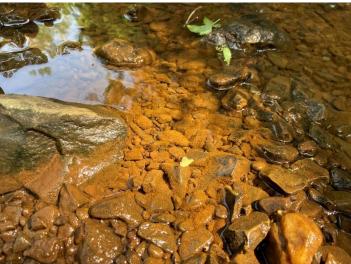
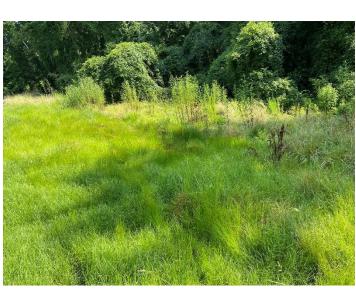
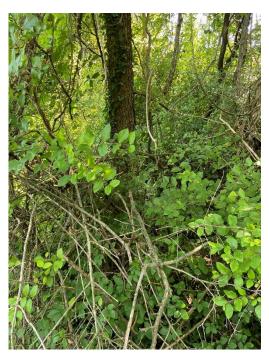
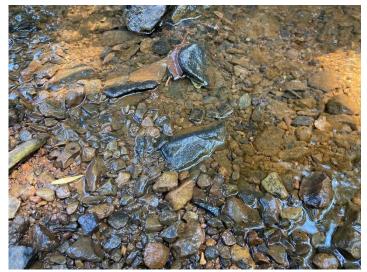
RE ZMA202300004 – Cornerstone Community Church. Perennial stream indicators suggest presence of a perennial stream E of Rt. 20 extending upstream. Features: bed /bank, riffle-pool sequence, .25-.5' depth photos: 7/26 – last precipitation, 7/21/23, 0.04". No measurable precipitation 7/22-7/26. Fairfax score = 33. (Source met data: National Weather Service)

photos: 7/26 – last precipitation, 7/21/23, 0.04".

No measurable precipitation 7/22-7/26.

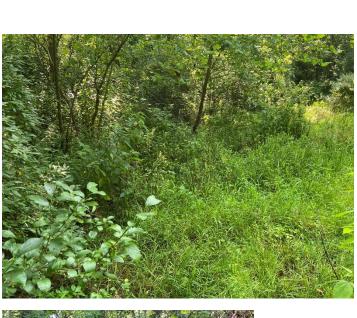
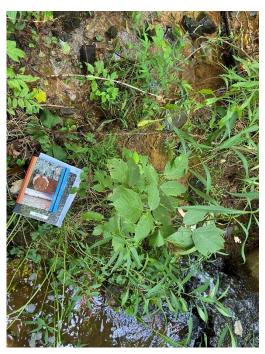
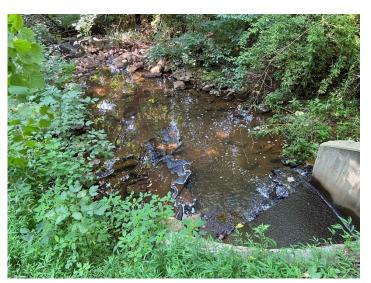
Indicators suggest presence of perennial stream at west inset between Pewter Ct. and Olympia Drive.

<u>Features</u>: Wet Pond Outfall (WPO), GSP (Groundwater seep or spring, immediately left of WPO; perennial indicators = 26.5 score @ WPO location), PIC (photos), WTL (wetland or marshy area approx. 50' above /left of WPO /appears perennial), HCT (headcut; minor, left of WPO), FSH (fish, ~4" length), RRC (riprap channel at WPO plunge pool, then natural, facing downstream). Area wooded. 0.25-.5' depth, width varies: 5' - 20'.

photos: 7/26 – last precipitation, 7/21/23, 0.04". No measurable precipitation 7/22-7/26.

<u>Image lower right (GIS)</u>: <u>1.</u> is location near Rt. 20; <u>2.</u> is location near Pewter Ct.-Olympia Drive. 7/26/23 Alb. County field evaluation appears to indicate perennial stream present along <u>blue highlight</u>, image lower right.
