APPENDIX B: CONCEPTS AND COMMENTS

East Alternative Concept

West Alternative Concept

APPENDIX C: ENGINEER'S ESTIMATE OF PROBABLE COST

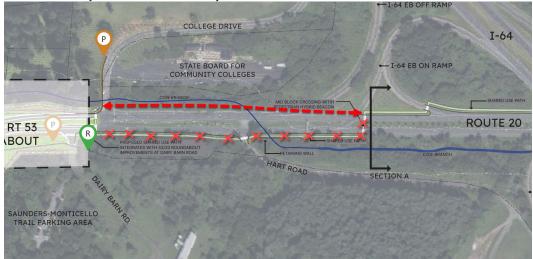
Figure 1: Possible modification to the Western Alternative suggested by VDOT.

VDOT Comment: investigate eliminating the mid-block crossing and keeping the SUP on the west side of Route 20 until the proposed crossing at the PVCC entrance.

The west shoulder of Route 20 in this area is one of the most constrained portions of the corridor due to the proximity of Cows Branch (see streetside image below). Significant retaining walls and environmental impact would result from this alignment. However, the costly mid-block crossing could be eliminated. A cost-benefit analysis of this alternative may be warranted.

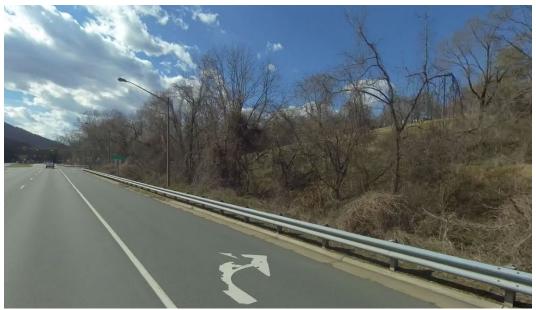
Photograph 1: Street view of Route 20, southbound, looking towards Cows Branch and PVCC.

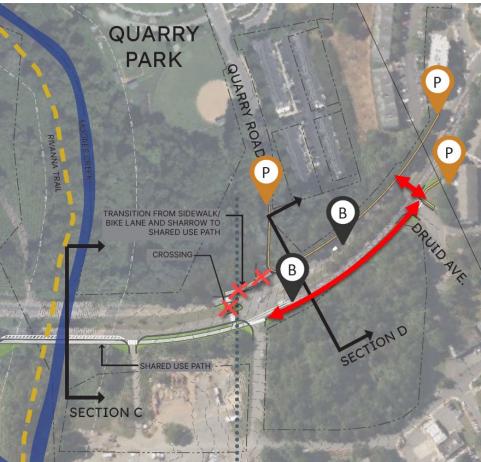
Figure 2: Possible extension of SUP into City, East Alternative

Extending the SUP along the East edge of the road would not be difficult and would be an improvement to the East Alternative. Extending the SUP in the West Alternative would likely require some retaining along the steep slope adjacent to the road, but should be possible. It is critical to note that a crossing of Route 20 must occur in this vicinity to connect the proposed shared use path to the existing pedestrian and bicycle facilities which appear on both sides of the road. Due to the presence of Quarry Park as a pedestrian generator, pedestrian desire paths and volumes may warrant the crossing to be marked at Quarry Road. If this is the case, it is not recommended to mark a crossing at Druid Avenue, due to the proximity of the two intersections. A mid-block crossing study should be performed for both locations at the preliminary engineering stage to determine which location is the most appropriate for the needed crossing, and should consider roadway slope, desire paths, specific locations of pedestrian generators, sight lines, accident history, and traffic volumes (see VDOT IIM-TE-384.1).

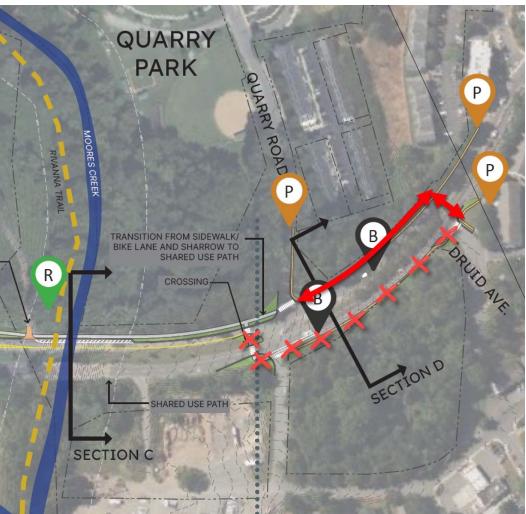
Figure 3: possible extension of SUP into City, West Alternative

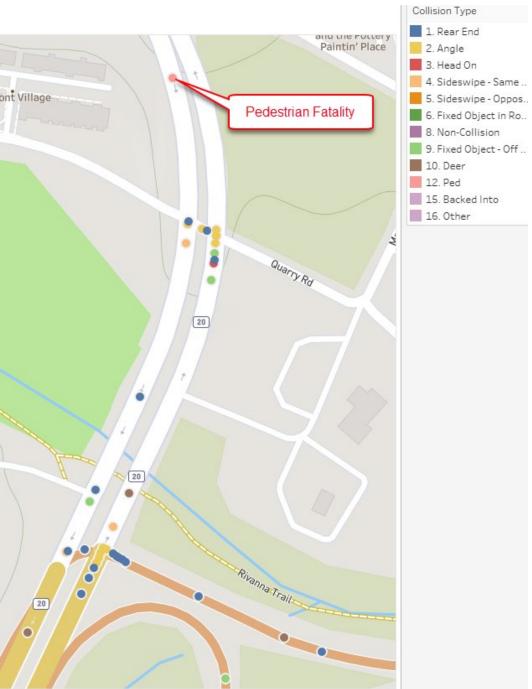
Image D1: Crashes from Druid Avenue to northernmost interstate ramp.

Note: The stop-controlled intersection of the I-64 WB off-ramp and Route 20 sees high crash rates. In 2019, channelization features were added to the left turn from the I-64 WB off ramp. This reduced the accident rate from 3.5 crashes/year before 2019 to 1.6 crashes/year after 2019. However, this area still sees many more crashes than its counterpart ramps, as the traffic volumes here are much higher.

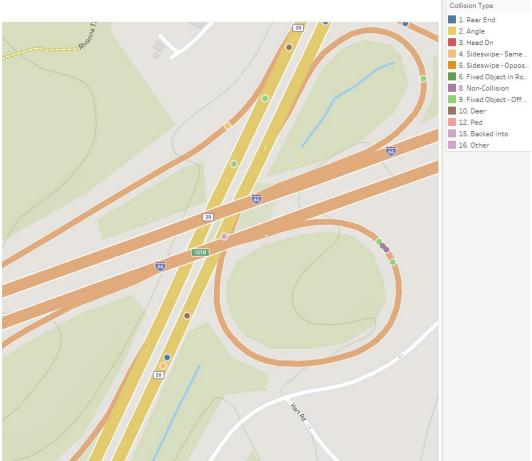
Image D2: Crashes along I-64 Interchange ramps (crashes on I-64 mainline not shown for clarity).

Note: very few accidents occur at ramp intersections with low traffic volumes. Most crashes in the area are due to deer or driver inattention.

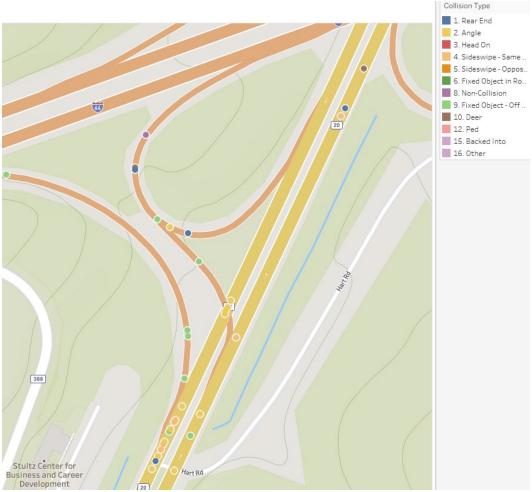
Image D3: Crashes from I-64 Interchange to Hart Road.

Note: crash rates in this vicinity justify a mid-block crossing in the West Alternative as opposed to the suggestion proposed by VDOT in which the path would continue along the western edge to the PVCC intersection.

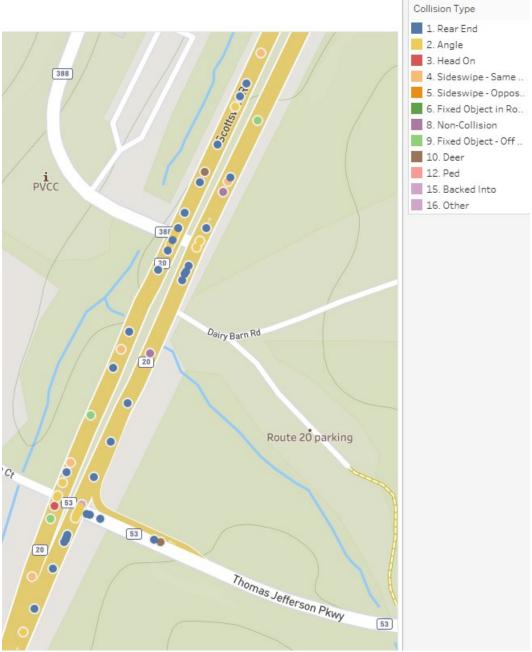
Image D4: Crashes from Hart Road to Route 53.

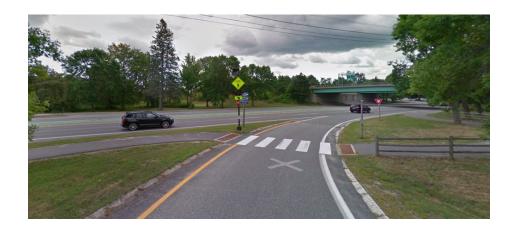
Saco, ME

Advance warning, flashing beacons, words on road (sometimes)

Rt. 195 W-bound exit onto Main St/Portland Rd

Cloverleaf off-ramp

TRAIL XING AHEAD signs in advance of the crossing

Button-activated flashing beacon at crossing

Stop sign for cyclists

Short crossing (narrow road, perpendicular crossing)

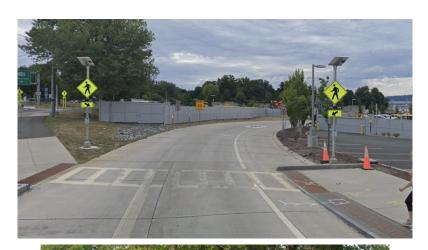
Tarrytown, NY

Broadway S on-ramp to 287 W

TRAIL XING sign ahead of ramp

Button-activated RRFB

Crossing perpendicular to travel lane

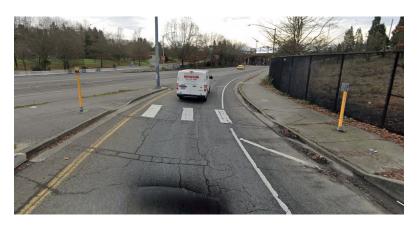
Seattle, WA

I-90 W-bound exit at Rainier Ave

Flashing "ped ahead" beacon before crossing is in view

PED XING painted on road

The crossing is only paint, no buttons or lights (the ped signs say "use caution when crossing")

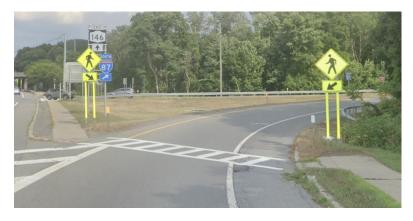
Clifton Park Center, NY

No flashing lights

146 E onto 84 S

3 large signs, one ahead of the others

Crossing not perpendicular to road, longer than it needs to be

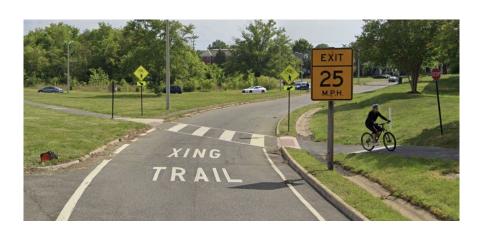
Arlington, VA

Arlington Blvd S off-ramp onto Washington Blvd N-bound

Sign ahead

TRAIL XING painted on road

No flashing lights

Crossing not perpendicular to road, longer than it needs to be

Signs potentially obscured by EXIT 25mph sign

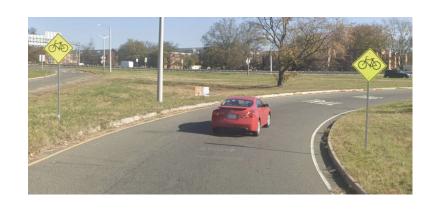
Arlington, VA

Washington Blvd N-bound on-ramp to Arlington Blvd W

Bike signs ahead

TRAIL XING painted

Just a crosswalk, not perpendicular, stop signs for cyclists

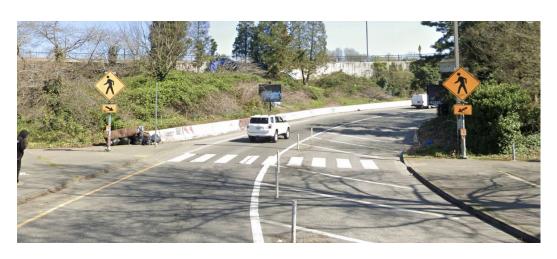
Seattle, WA

Rainier Ave on-ramp to I-90 E

Flashing beacons

Poles used to narrow roadway

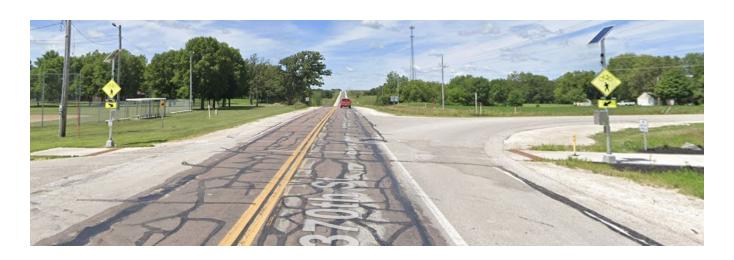
Auburn, IA

Thermal detection flashing beacons

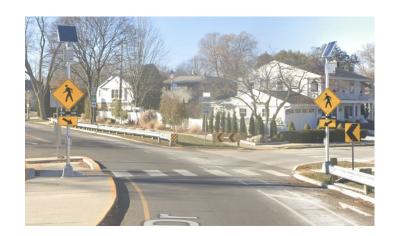
Whitefish Bay, WI

RRFB with a flashing beacon 50m ahead of the crossing
