**TO:** Albemarle County Community Development  
**FROM:** Turkey Knob Solar Farm, LLC

# Project Narrative

Supplement to Application for Special Exception  
Request

**TURKEY KNOB SOLAR**  
 ALBEMARLE COUNTY - VIRGINIA

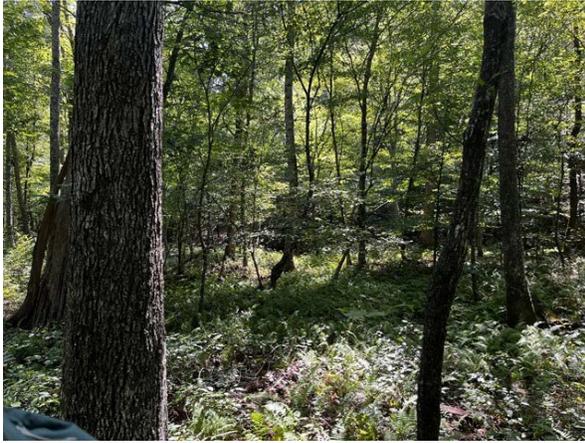
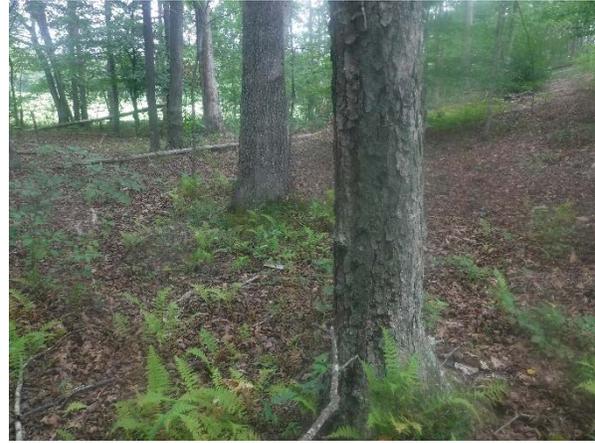
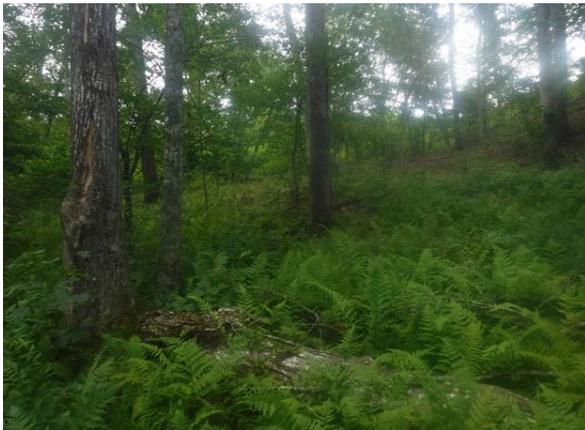
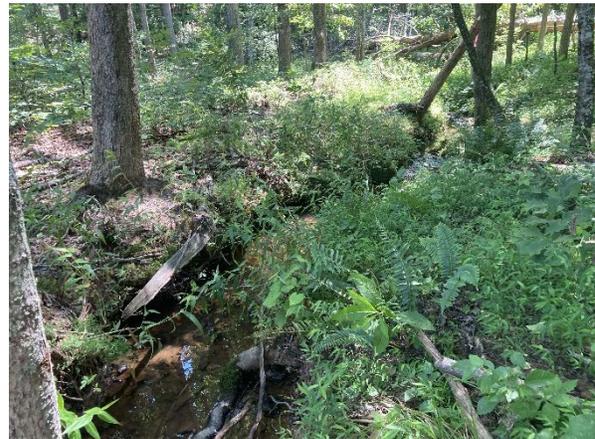
Photo 1: Mature forest; taken in the eastern corner of the site

Photo 2: Mature forest; taken in the lower swales along the northern project boundary

Photo 3: Mature forest; taken in the lower swales along the northern project boundary

Photo 4: Mature forest; taken in the southwestern corner of the site

Following the extensive clearing of forests across the majority of the site, DCR's map of forest conservations values, along with forest block maps in Albemarle County's BAP, are outdated and do not reflect current conditions. The site is now dominated by timbered areas; remaining forest stands are limited to narrow corridors within swales and drainage pathways that convey runoff offsite, reflecting a fragmented pattern of regrowth rather than intact forest habitat. It is Timmons Group's professional opinion that the 24.57 combined acres of early- and mid-successional forested areas onsite are not mature enough to perform as a forest block. The mature forests onsite must exceed 10 acres of interior forest to qualify for a small forest block, as defined on [Figure 4](#). The mature forests onsite are fragmented and only have a combined acreage of 9.50; therefore, no forest blocks are present onsite.

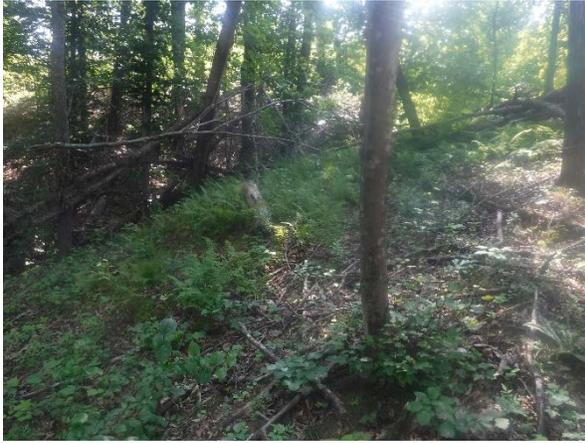
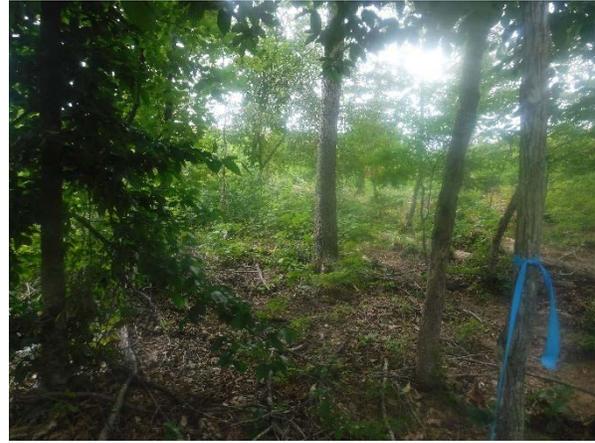
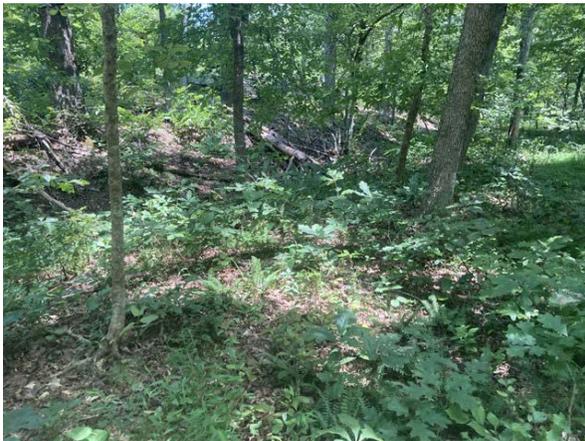
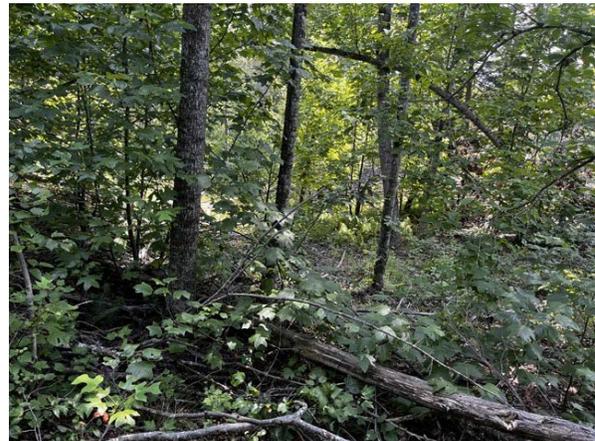
Photo 5: Mid-successional forest; taken along the northeastern project boundary

Photo 6: Mid-successional forest; taken in the swale off the northwestern project boundary

Photo 7: Mid-successional forest; taken in the southwest corner of the site

Photo 8: Mid-successional forest; taken near the eastern corner of the project

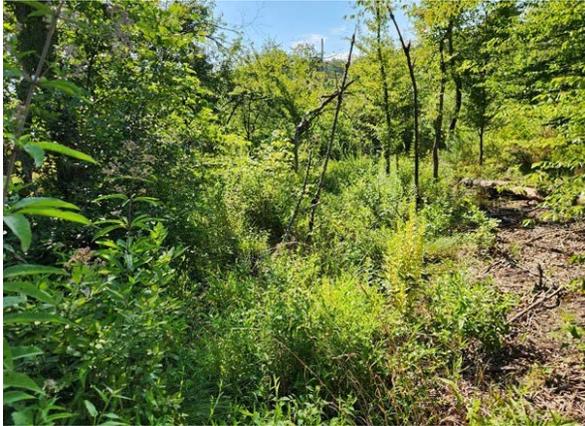
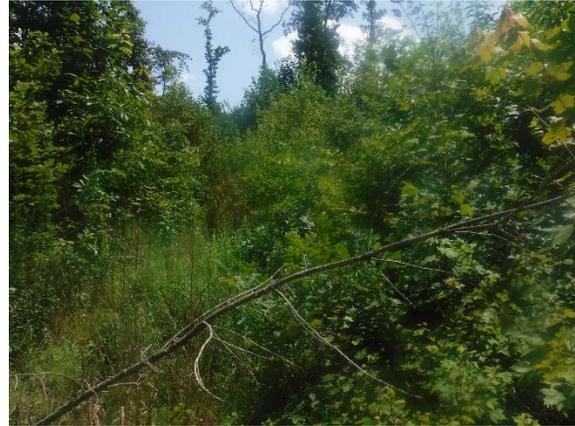
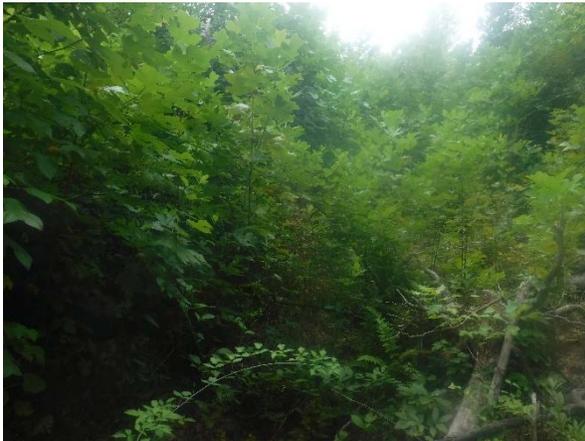
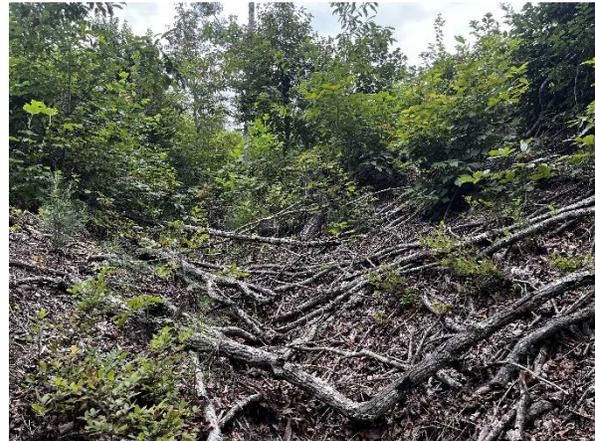
Photo 9: Early-successional forest; taken near the northwestern project boundary  
(08/04/2025, J. Garrett)

Photo 10: Early-successional forest; taken in an upper swale along the northern project boundary  
(08/04/2025, M. Norris)

Photo 11: Early-successional forest; taken in an upper swale along the northern project boundary  
(08/05/2025, M. Norris)

Photo 12: Early-successional forest; taken along the southeast project boundary  
(08/05/2025, A. Whitlock)

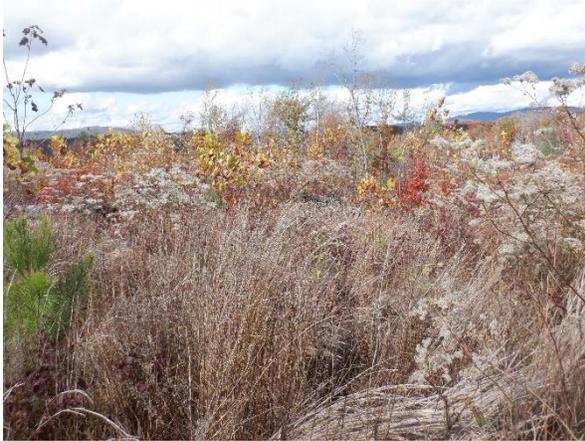
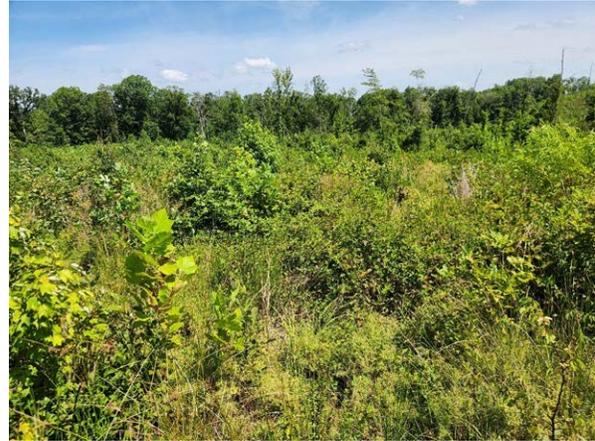
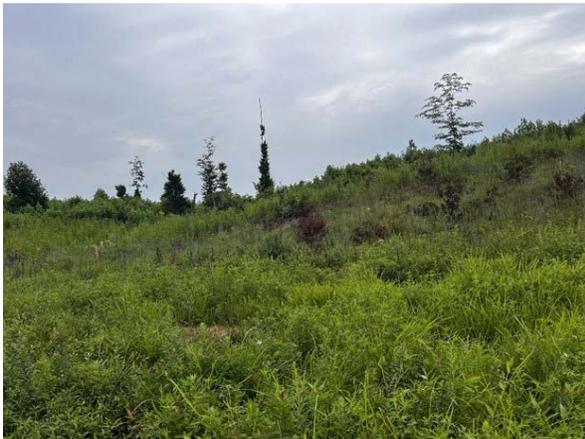
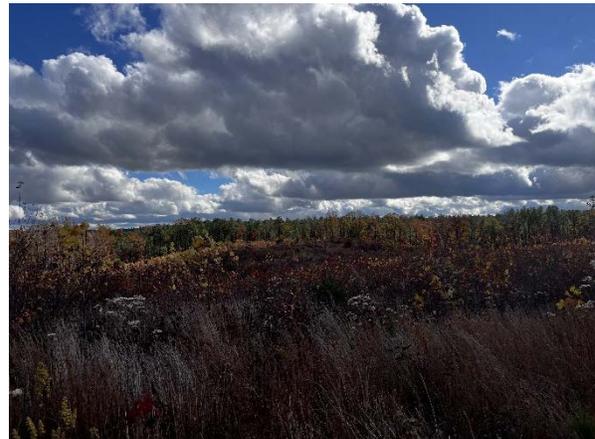
Photo 13: Timbered areas; taken in the eastern portion of the site

Photo 14: Timbered areas; taken in the western portion of the site

Photo 15: Timbered areas; taken in the center of the site in a maintained easement

Photo 16: Timbered areas; taken in the center of the site
