# BIRDWOOD LANDSCAPE

## SITE PROTECTION AND STEWARDSHIP STRATEGIES PLAN

# EVOLUTION OF THE BIRDWOOD LANDSCAPE

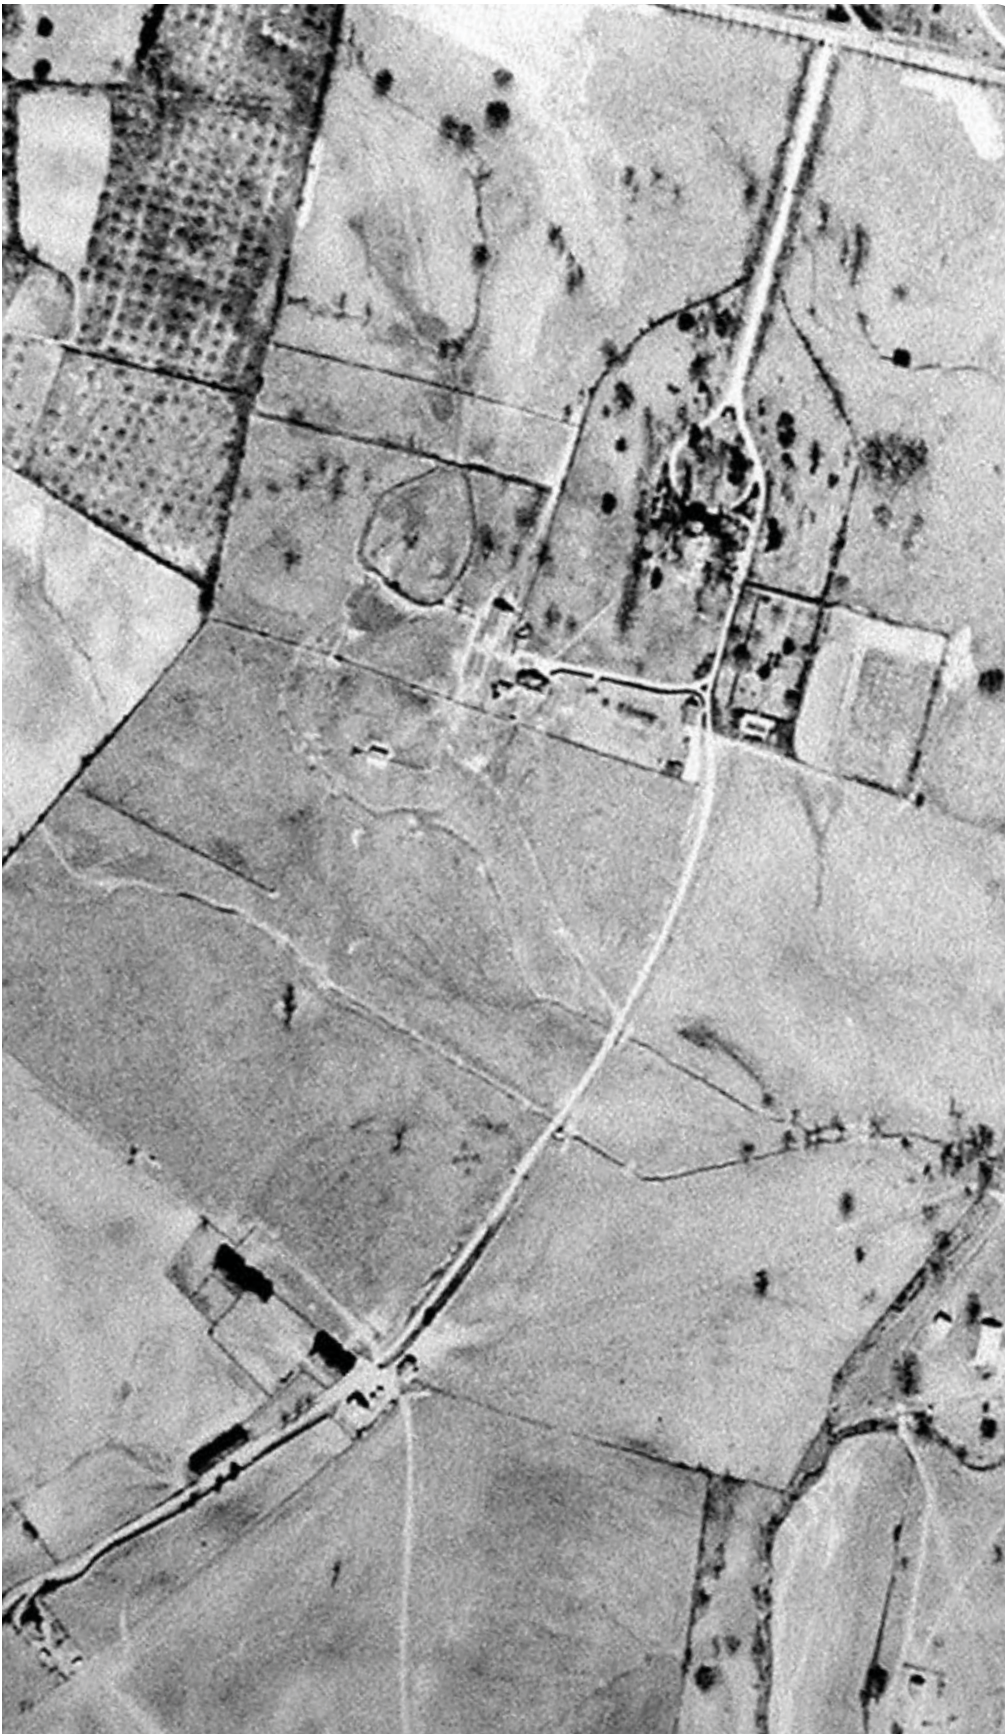
1937 aerial photograph of Birdwood showing the buildings, ornamental garden areas, orchards, fields, roads, and trees

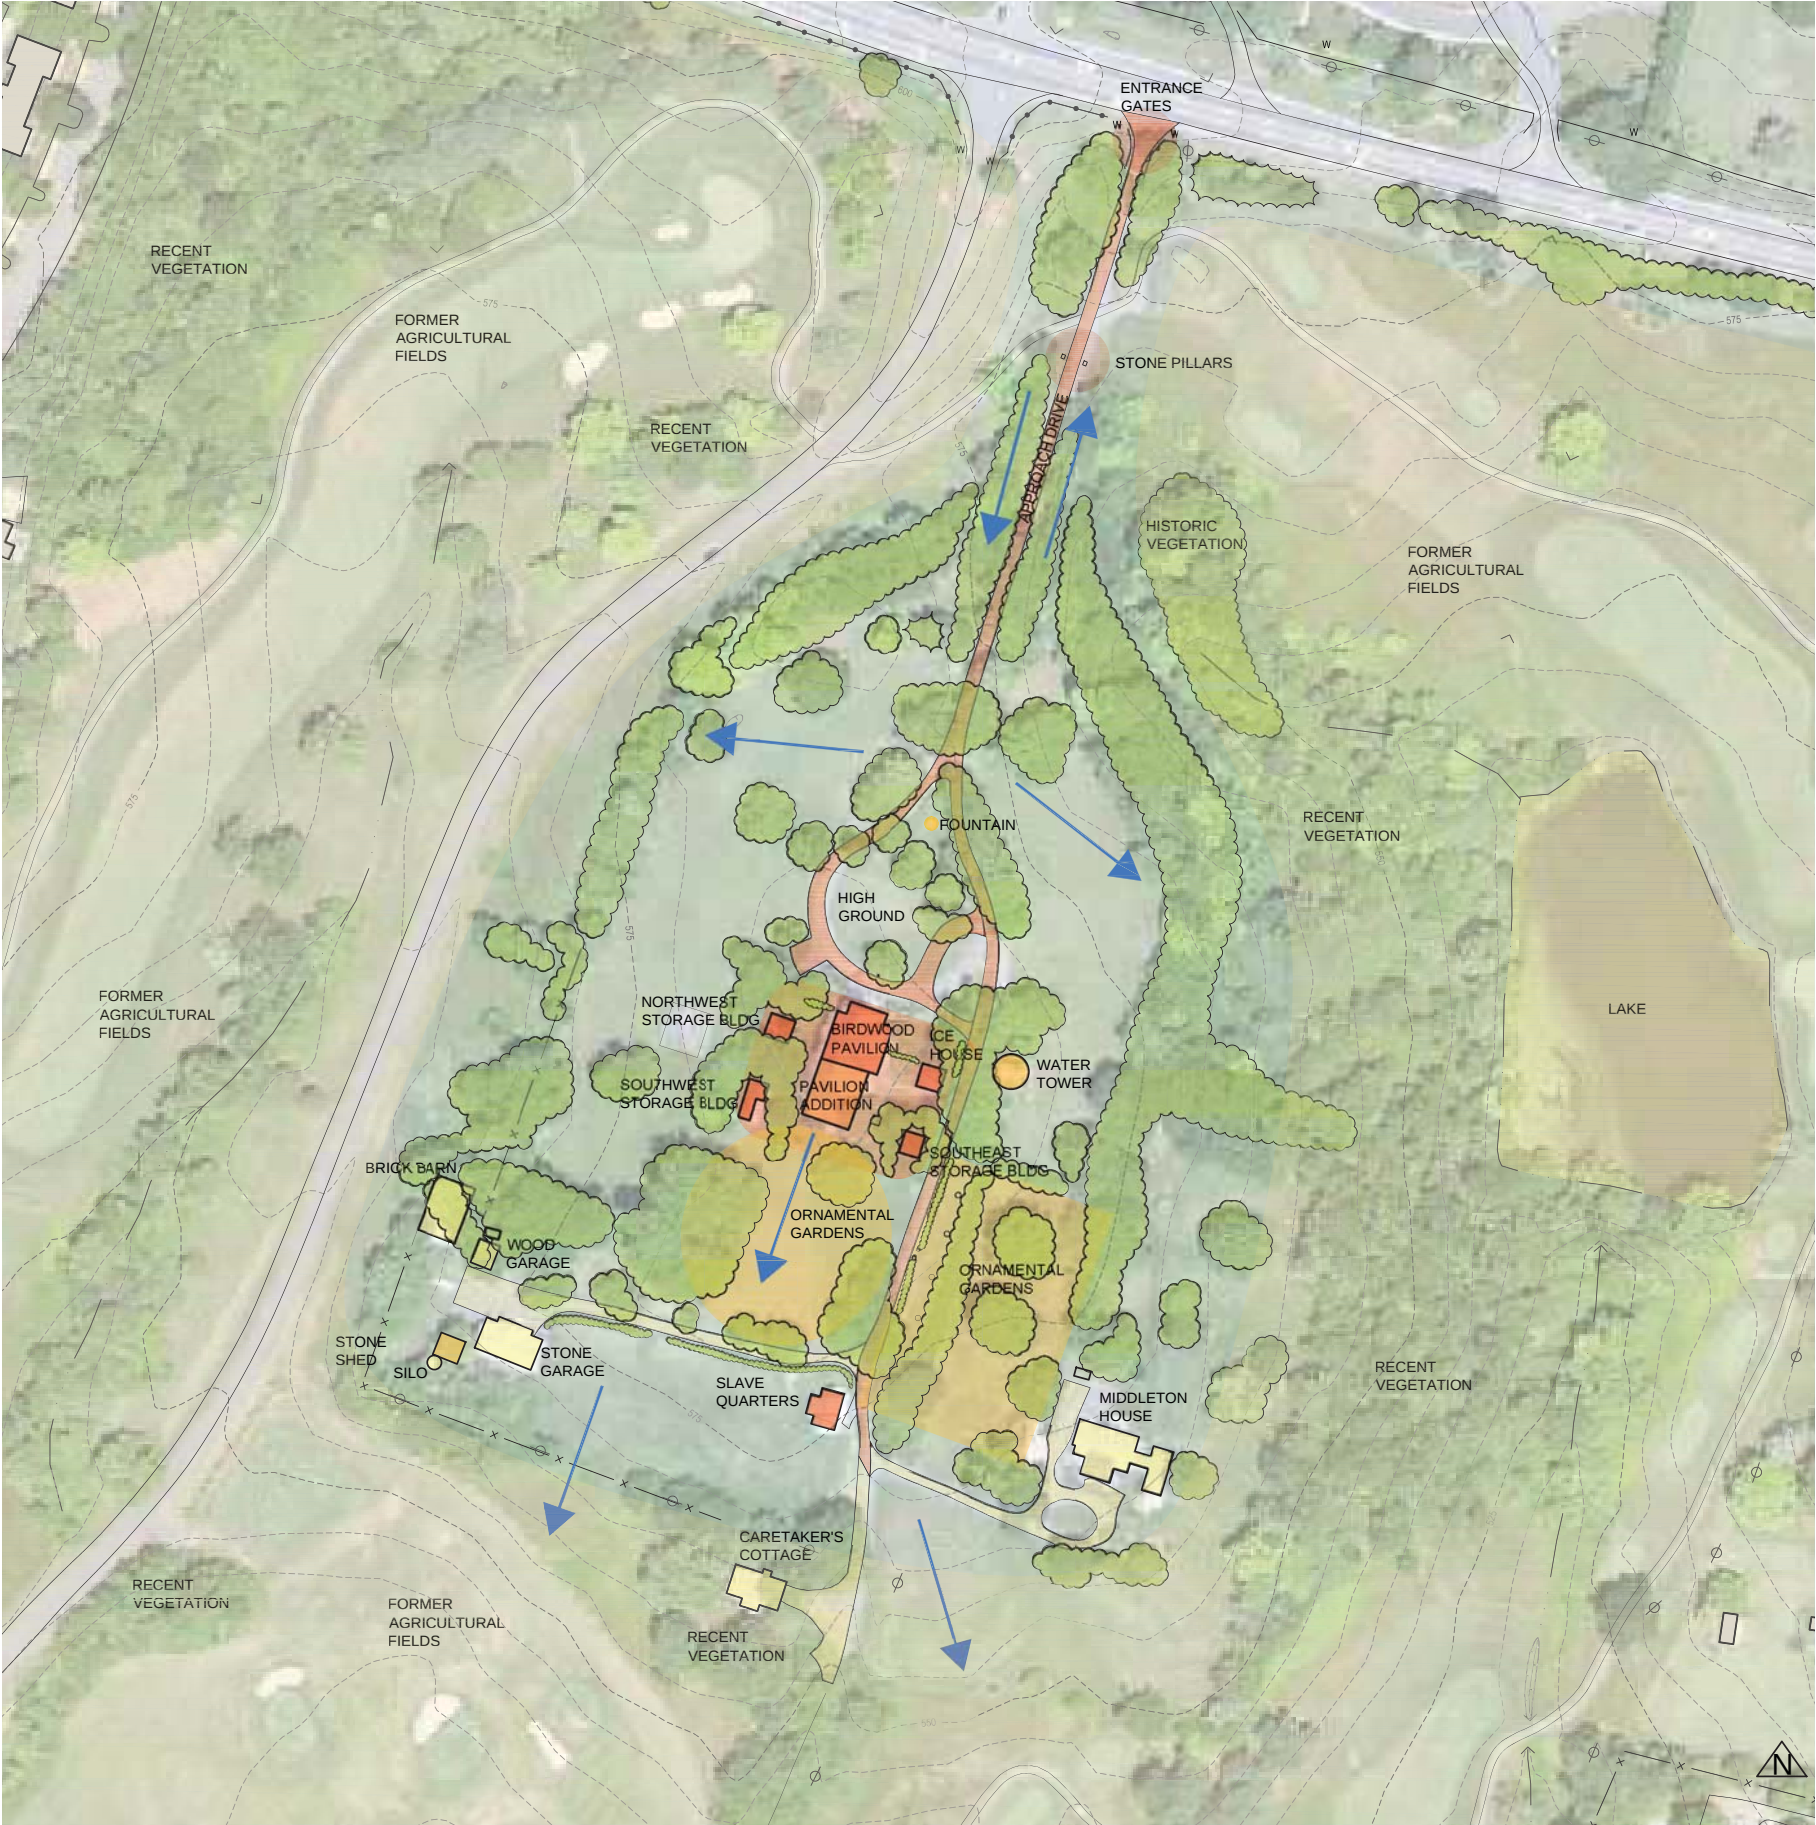
BIRDWOOD SITE PLAN: EXTANT HISTORIC LANDSCAPE FEATURES

EXTANT HISTORIC STRUCTURES AND LANDSCAPE FEATURES

- Features from the William Garth Era (1819-1878)**

Birdwood Pavilion, c. 1819-1830  
Slave Quarters, c. 1819-1830  
Ice House, c. 1830  
Northwest Storage Building, c. 1830  
Southeast Storage Building, c. 1819-1830  
Southwest Storage Building, c. 1819-1830  
Agricultural Landscape  
Approach Drive with Circle near Pavilion
- Features from the Samuel Buck-William Chamberlain Era (1879-1908)**

Agricultural Fields  
Pavilion Addition  
Trees in Front Lawn  
Allee of Trees along Approach Drive (?)  
Pecan Trees in Rear Lawn (?)
- Features from the Hollis Rinehart Era (1909-1920)**

Ornamental Gardens  
Water Tower, c. 1909  
Stone Shed, c. 1909  
Hedges near Front Portico  
Marble Fountain (?)
- Features from the Working Landscape era (1920-1967)**

Wood Garage, c. 1920  
Barn, c. 1925  
Charles Gillette Garden, c. 1928 (?)  
Silo, c. 1930  
Stone Garage, c. 1940  
Middleton House, c. 1940  
Caretaker Cottage, 1945  
Lake
- HISTORIC LANDSCAPE CHARACTERISTICS**

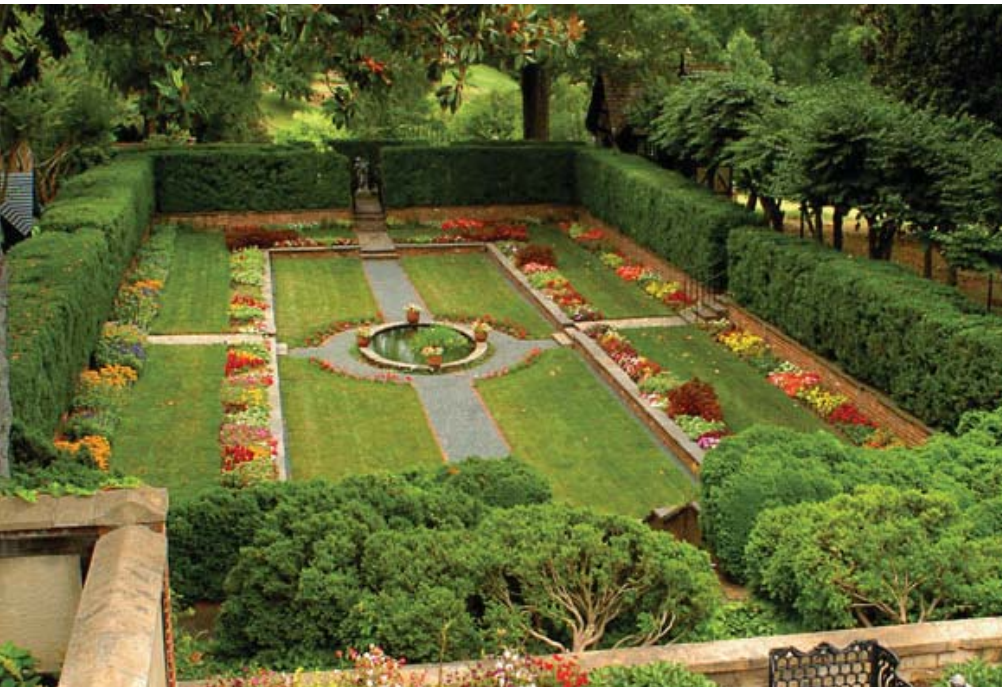
Comparison photograph showing a similar eclectic style at Agecroft Hall gardens, designed by Charles Gillette
